Towbar Fitting Instructions  
To Suit MERCEDES BENZ VITO VAN  
Part Number QTMB426  
Rating 2000Kg

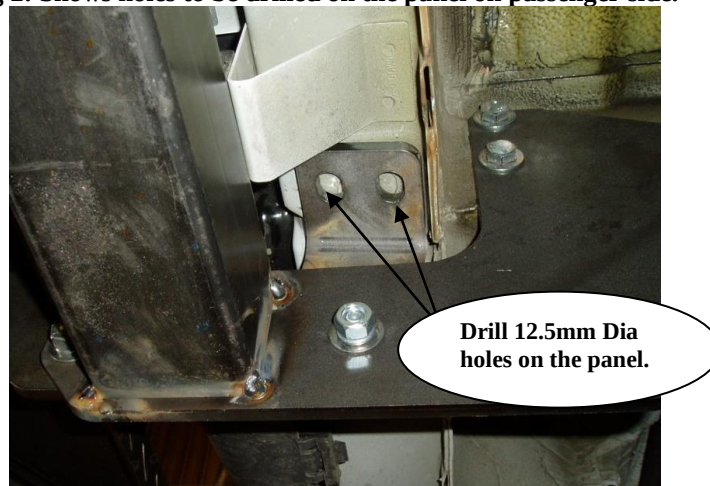
Fig 2: Shows holes to be drilled on the panel on passenger side.

- a) Drill holes on the vertical face of the passenger side chassis as shown in Figure 1, using a 25mm hole saw.
  - b) Drill 12.5mm diameter holes on the chassis of the vehicle as shown in Figure 2, on the passenger side.

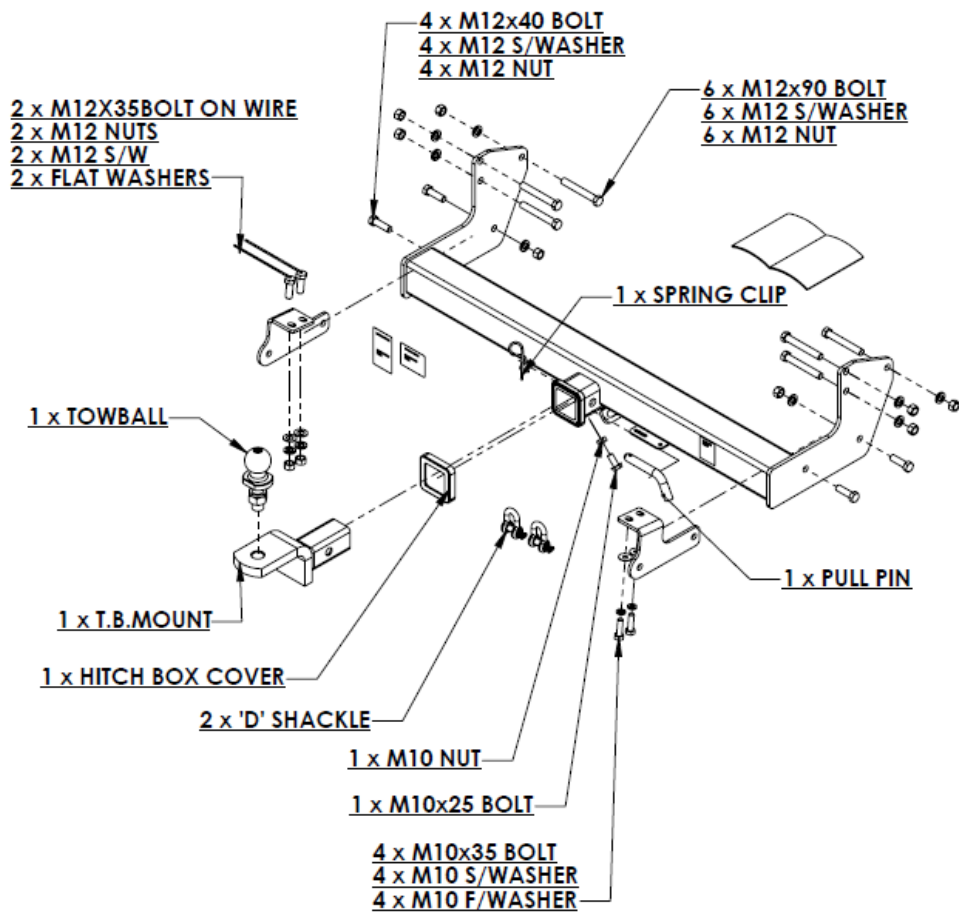
Bolts with wires that have been inserted through the drilled holes.
